Effects of Varying Ball Bearing Cleaning Processes on Lubricant Life

20 January 1998

NASA-GODDARD Green Belt, MD 20771

Contract No. F04701-93-C-0094

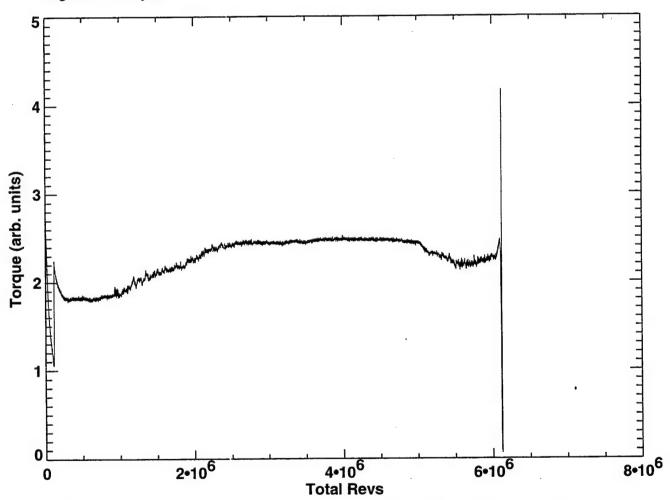
Figure 1 shows the test fixture reaction torque trace for a typical test run in this program. After an initial run-in period characterized by decreasing reaction torque, the bearings typically operated at a relatively constant torque level until failure of the lubricant system. At that time, the test fixture either showed a rapid increase in the reaction torque or began to operate in an unstable mode where a negative reaction torque was recorded for a short period prior to increasing dramatically. In these tests, we have taken the onset of unstable behavior as failure and have verified that the lubricant has degraded at that juncture.

Figure 1. A reaction torque trace for a typical test run to failure in this program. This specific test was run on components cleaned with Vertrel XF. The discontinuity after 1 X 10³ revolutions is caused by an adjustment to the zero level of the torque sensor.

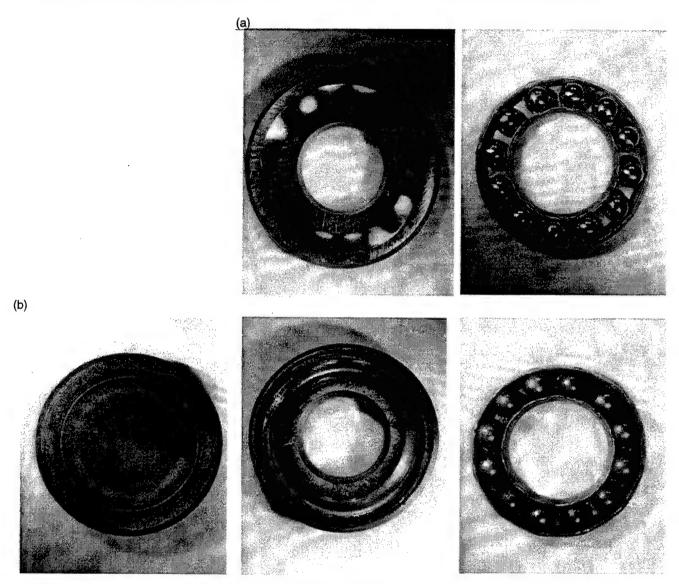
Figure 2 presents photographs comparing new bearing components to those typically found following the termination of a test based on our failure criteria. The test bearing components are covered with a black residue that is characteristic of the degradation of a PFPE lubricant under boundary contact.

Figure 2. Photographs of bearing test components taken (a) before a test and (b) after test failure. The black residue is characteristic of the failure of PFPE lubricants. This test was conducted on components cleaned with the Vertrel XF.

As shown in Figure 2, the failure of these bearings results from the degradation of the 815Z lubricant. In previous work, analysis of this residue has shown it to contain polymerized PFPE mixed with iron wear particles and FeF₃, which is believed to catalyze the decomposition of the oil. From these results, we conclude that the cleaning processes employed in our tests affect the rate at which the 815Z lubricant is degraded under mechanical contact. This degradation must be related to the surface chemical composition of the bearing components, implying that the different cleaning methods produce different surface chemistry. To determine possible reasons for this behavior, cleaned components were analyzed with FTIR and XPS to assess the chemical composition of the component surfaces.

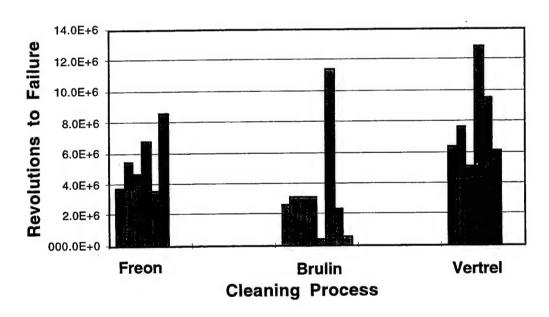
Figure 3 provides a graphical representation of the endurance of all of the tests conducted with components cleaned with the three different processes. Each bar on the graph represents a test to failure, and the variation from run-to-run for a given set of conditions is fairly common for this fixture. The primary reason for this variation is likely the relatively poor quality of the bearing components being used, particularly the stamped steel cage, which can wear unpredictably and may be altered by the substitution of the 440C balls. Even with the variation, some obvious trends are present in our data. Specifically, components cleaned with the detergent process have a shorter operational life than those cleaned with Freon TF, while bearing items cleaned with the Vertrel XF solvent demonstrated a significantly longer life.

In comparing the detergent-cleaned results to the Freon TF results, only one Brulin test lasted as long as the shortest-lived Freon TF test. That particular detergent test was one of the longest of all of the tests, and should probably be discounted as an anomaly. The remainder of the detergent tests lasted for approximately 3 million or fewer revolutions, including two tests that were very short lived. All of the Freon TF-cleaned bearings lasted for at least 3.5 million revolutions and ranged up to 8.5 million (with most between 3.5 and 7 million). In contrast, all Vertrel- bearings lasted a minimum of 5 million, with one lasting as long as 13 million revolutions. Most of the Vertrel XF tests were in the range of 6 to 10 million.

Figure 3. Graph showing the individual tests run to failure for each of the three cleaning processes. Each bar represents a single test, with the endurance given in the total number of revolutions.

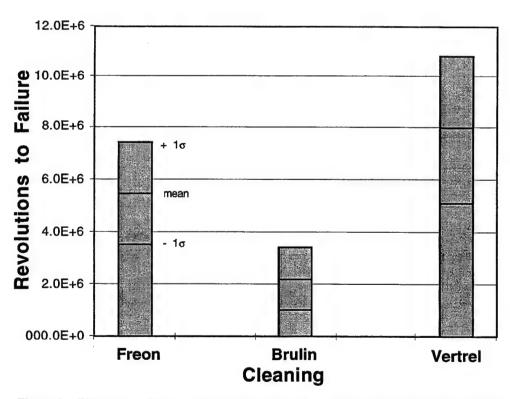
Figure 4 presents the mean wear lives for the tests (omitting the one very long-lived detergent-cleaned bearing result) and the standard deviation for these results. These results show that, on average, the Freon TF-cleaned components lasted about 2.5 times longer than those cleaned with Brulin. The Vertrel XF-cleaned components last about 1.5 times longer than those cleaned with Freon TF. Overall, it is evident that the cleaning method could impact the lubricant life by nearly a factor of 4 when comparing the Vertrel XF-cleaned samples to those cleaned with detergent. However, the reasons for the variations must be assessed before the assumption of the superiority of one cleaning method based on the test results can be made.

Figure 4. The mean endurance of the wear test data from Figure 3 for each of the cleaning processes. The mean value is given by the line indicated for the Freon data. The values of ± 1 standard deviation are also provided on the graph. The Brulin data were averaged without the longest lived test.

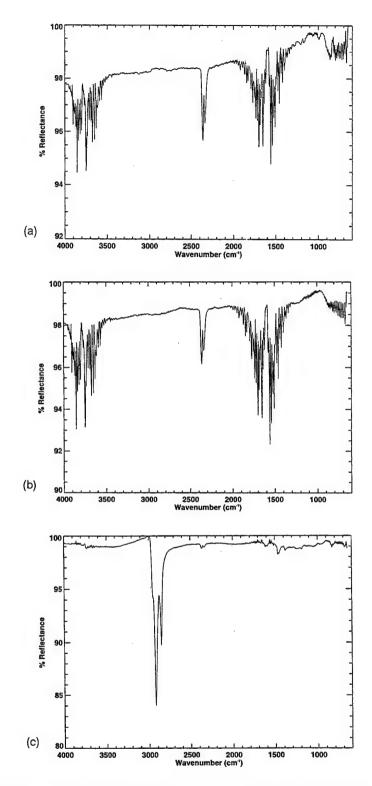
Figure 5 compares the FTIR spectra obtained on balls processed through the limited cleaning procedures described in the experimental section. The most striking result is the obvious presence of carbon-hydrogen stretching vibrations near 3000 cm⁻¹ on the ball cleaned with the Vertrel XF, and the absence of these features on the balls cleaned with Freon TF and Brulin. The features observed in the Freon TF and Brulin spectra were obtained at high sensitivity, and the resulting features are due to atmospheric gases that could not be completely purged from the system. These results are consistent with the observed difficulty in removing the protective mineral oil on the steel parts with the Vertrel XF solvent. The results also provide a possible explanation for the longer life of the components cleaned with the Vertrel XF since the thick residual hydrocarbon overlayer probably provided some boundary protection (especially if the oil contained boundary additives), delaying the degradation of the PFPE lubricant. Although this cleaning process may have extended the life of the bearing, it did so by being an ineffective solvent and leaving behind a beneficial lubricating residue. It would be unwise to rely on such a process for assuring long life since ineffective cleaning is uncontrollable and assuredly not always beneficial.

In Figure 5, neither the Freon TF-cleaned nor the Brulin-cleaned ball had a detectable hydrocarbon signature in the FTIR, which is sensitive to films on the order of hundreds of Ångstroms These cleaning processes, therefore, have effectively removed much of the hydrocarbon overlayer. More surface-sensitive probes must be used to determine whether the difference in the operational life of test bearings cleaned by these processes is due to a beneficial hydrocarbon residue left behind by Freon TF or some other change in surface chemistry caused by the detergent process. To address this issue, XPS analyses of balls cleaned by our processes were performed.

Figure 5. FTIR data obtained from bearing balls cleaned as described in the text with (a) Freon TF, (b) Brulin 815 GD, and (c) Vertrel XF.

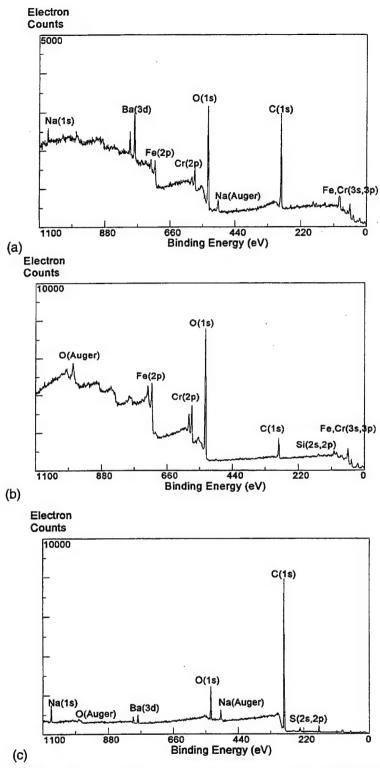
Figure 6 compares the XPS data obtained from oil-stored balls that were subjected to complete cleaning processes identical to those used to prepare bearings for test. These data show large differences in the composition of the near-surface region that depend sensitively on the cleaning process used. In particular, the intensity of the C 1s peak, centered at the characteristic binding energy for a hydrocarbon (284.6 eV), is very strong on the Vertrel-cleaned article (Fig. 6C), is much weaker on the Brulin-cleaned samples (Fig. 6B), and has an intermediate intensity on the Freon TF-cleaned samples (Fig. 6A). The intensities of spectral features from the substrate, particularly the Fe and Cr 2p peaks near 710 and 580 eV, respectively, also vary significantly with the cleaning process. A thick contaminant layer on the Vertrel-cleaned ball completely obscures the substrate features. On the Freon TF- and Brulin-cleaned balls, both substrate elements are evident, but they are clearly more intense for the Brulin ball, consistent with a thinner hydrocarbon contaminant layer, as expected from the lower carbon signal intensity. It should be noted that the sensitivity of XPS to the different elements varies greatly, and the relative concentrations of species can be determined using known elemental sensitivity factors as shown below. In addition, some trace elements were detected as indicated on the spectra. In particular, Na, Ba, and S were observed on the Freon TF- and Vertrel-cleaned balls, while a small amount of Si was detected on the Brulin-cleaned samples. We believe that the Na, Ba, and S contributions come from additives or impurities in the protective oil, while the Si is a residue of the Brulin process that has been observed before.

Figure 6. XPS survey scans obtained on bearing balls cleaned with (a) Freon TF, (b) Brulin 815 GD, and (c) Vertrel XF. Prior to cleaning, the balls had been stored with a protective mineral oil coating. The identities of the major peaks are provided on the spectra.

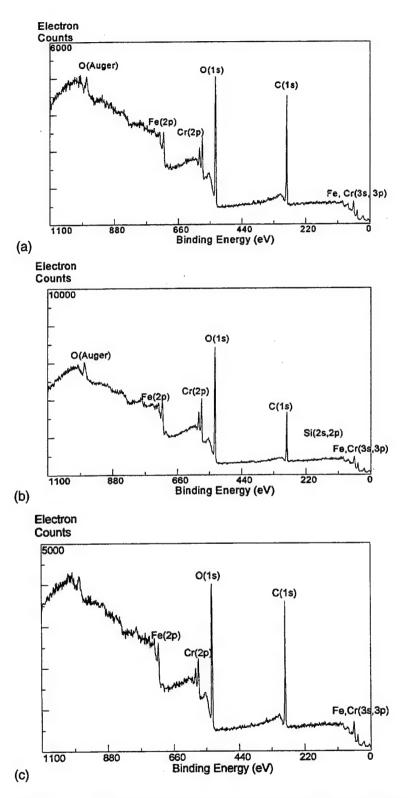
Figure 7 compares typical XPS survey scans taken from cleaned balls that were stored without the oil coating. The results from the Freon TF (Fig. 7A) and Vertrel XF (Fig. 7C) cleaning are very similar, and the main difference among the three spectra is the smaller amount of carbon and corresponding stronger substrate features always detected on Brulin-cleaned surfaces. The quantitative surface concentrations are presented in Table 2. As expected from Figure 7, the Freon TF- and Vertrel XF-cleaned samples have very similar chemical compositions, and the Brulin is again cleaner. None of the oil-related trace elements were detected on these balls, but a weak silicon signal was observed on the Brulin-cleaned surface. The amount of silicon detected was small, just above the detection limits for the technique, but its presence on all Brulin-cleaned balls indicates the potential for concern should inadequate rinsing become a process problem.

Figure 7. XPS survey scans obtained on bearing balls cleaned with (a) Freon TF, (b) Brulin 815 GD, and (c) Vertrel XF. Prior to cleaning, the balls were stored without any oil coating.

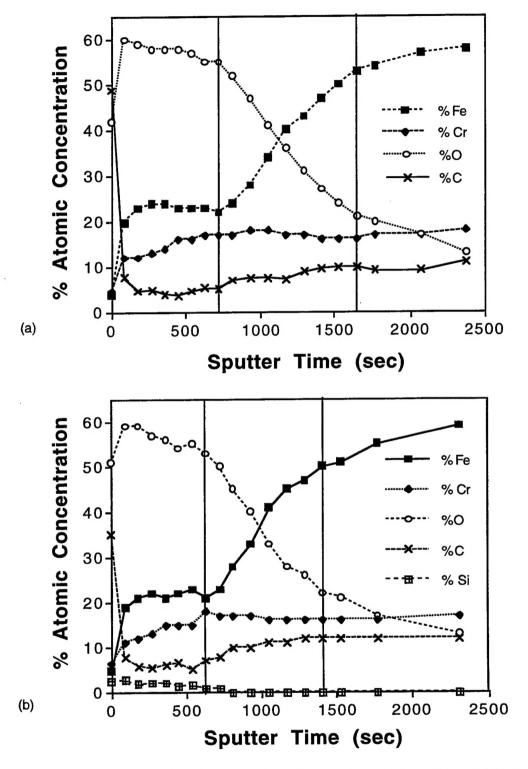
Figure 8 compares the sputter profile obtained from a Freon TF-cleaned 440C ball to that from a Brulin-cleaned ball. Each profile has four distinct regions. The surface hydrocarbon overlayer is virtually removed after the first two sputter cycles, causing the large decrease in the carbon contribution and the significant increases of all the other constituents. (Hydrocarbon layers are easier to remove by sputtering than is the substrate, so one should not conclude that these layers are only 4–6 Å thick based on the assumed sputtering rate.) The three steel-related regions are approximately divided by the solid vertical lines on the two profiles. The first region is characterized by a slowly declining oxygen concentration coupled to approximately constant Fe and C, and slowing rising Cr concentrations. The detailed spectra obtained during this period clearly show a decreasing iron oxide signal, and previous work has concluded that an iron oxide overlayer exists on 440C; this overlayer is being sputtered away in this time frame.

With increasing sputter time, the next region is characterized by fairly dramatic changes. The oxygen signal falls steeply while the iron signal rises. The Cr concentration drops slightly while C increases. These changes coupled to the detailed data show that a chromium oxide underlayer is being sputtered away during this time period. The spectral changes differentiating this zone from the bulk steel are not sharp, and the line has been drawn to mark the times where the dramatic spectral changes become more gradual.

Comparing the two sputter profiles, three differences are evident, but they are subtle differences. First, the times required to sputter away the oxide layers on the Freon TF-cleaned ball are slightly longer than those required for the Brulin-cleaned ball. This difference is evident in both the iron oxide overlayer and the chromium oxide underlayer. The combined difference translates into a total oxide overlayer that was approximately 6Å thicker on the Freon TF-cleaned component. The second difference is that the boundaries between the regions seem more distinct on the Freon TF-cleaned ball. For example, it is much easier to distinguish the break between the iron oxide and chromium oxide layers in Figure 8A, perhaps indicating that these layers are better formed prior to the detergent cleaning. The final noted difference is the absolute carbon concentration, which is consistently higher in the surface region of the Brulin sample and has the characteristic binding energy of carbide species after the hydrocarbon is removed. Chromium carbides are known to oxidize more slowly than the metal, ¹⁰ and this may indicate that the oxide overlayers were significantly disrupted by the detergent cleaning process. All of these differences may be caused by sample variations, and a more exhaustive survey of these effects should be conducted.

Figure 8. XPS sputter profile of a 440C bearing ball cleaned with (a) Freon TF and (b) Brulin 815 GD. The solid vertical lines indicate the approximate locations of interfaces described in the text.
